Uniform Mitigation Verification Inspection Form

Inspection Date: JANUARY 30, 2020		
Owner Information		
Owner Name: MIDDLEBROOK PINES CONDOS CASE#: 20200130-WMIR-23		Contact Person: KEITH KIEBZAK
Address: 5290, 5292, 5294, 5296 BROOK CT - BLDG 23		Home Phone:
City: ORLANDO	Zip: 32811	Work Phone: 407-482-2622
County: ORANGE	FL	Cell Phone:
Insurance Company:		Policy #:
Year of Home: 1985	# of Stories: 2	Email: KLMGMTGROUP@AOL.COM

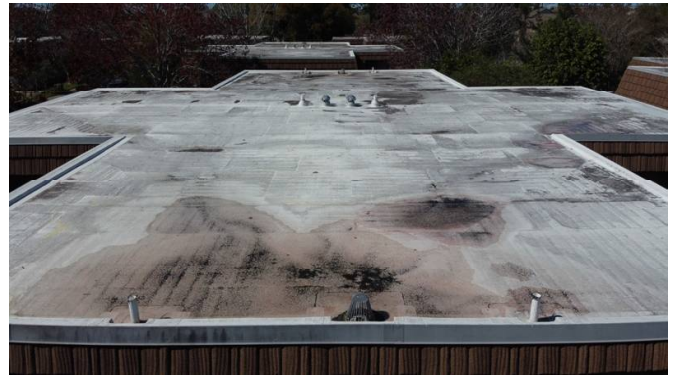
2.1 Roof Covering Type:	Permit Application Date	FBC or MDC Product Approval #	Year of Original Installation or Replacement	No Information Provided for Compliance
<input type="checkbox"/> 1. Asphalt/Fiberglass Shingle	____/____/____	_____	_____	<input type="checkbox"/>
<input type="checkbox"/> 2. Concrete/Clay Tile	____/____/____	_____	_____	<input type="checkbox"/>
<input type="checkbox"/> 3. Metal	____/____/____	_____	_____	<input type="checkbox"/>
<input type="checkbox"/> 4. Built Up	____/____/____	_____	_____	<input type="checkbox"/>
<input type="checkbox"/> 5. Membrane	____/____/____	_____	_____	<input type="checkbox"/>
<input checked="" type="checkbox"/> 6. Other Concrete/TPO	4/19/2011	_____	_____	<input type="checkbox"/>

ROOF - CONCRETE WITH TPO COVERING

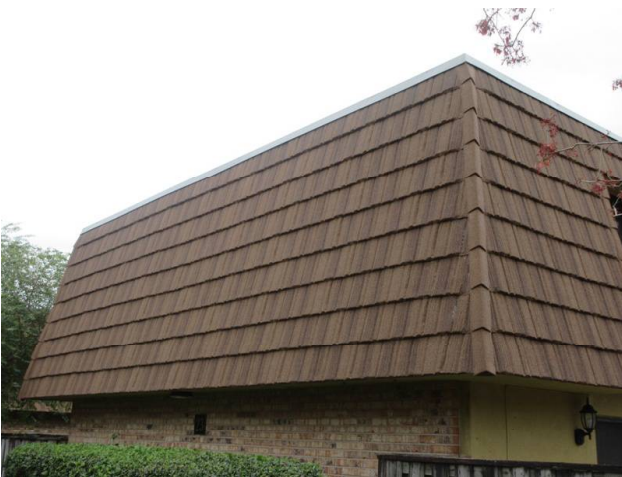
MANSARD WALLS REPLACED 2018
