# Uniform Mitigation Verification Inspection Form

Inspection Date: JANUARY 30, 2020		
<b>Owner Information</b>		
Owner Name: MIDDLEBROOK PINES CONDOS CASE#: 20200130-WMIR-25		Contact Person: KEITH KIEBZAK
Address: 5282, 5284, 5286, 5288 BROOK CT - BLDG 25		Home Phone:
City: ORLANDO	Zip: 32811	Work Phone: 407-482-2622
County: ORANGE	FL	Cell Phone:
Insurance Company:		Policy #:
Year of Home: 1985	# of Stories: 2	Email: KLMGMTGROUP@AOL.COM

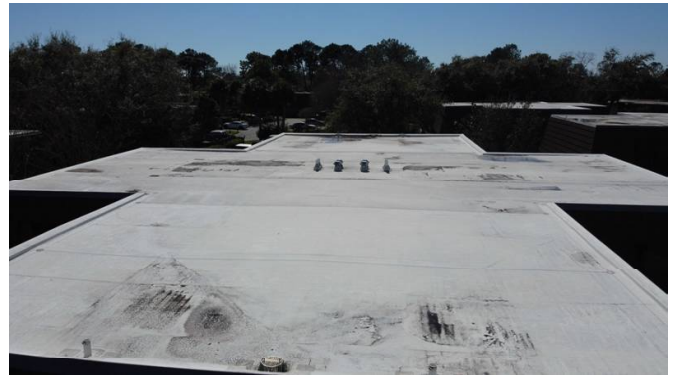
2.1 Roof Covering Type:	Permit Application Date	FBC or MDC Product Approval #	Year of Original Installation or Replacement	No Information Provided for Compliance
<input type="checkbox"/> 1. Asphalt/Fiberglass Shingle	___/___/___	_____	_____	<input type="checkbox"/>
<input type="checkbox"/> 2. Concrete/Clay Tile	___/___/___	_____	_____	<input type="checkbox"/>
<input type="checkbox"/> 3. Metal	___/___/___	_____	_____	<input type="checkbox"/>
<input type="checkbox"/> 4. Built Up	___/___/___	_____	_____	<input type="checkbox"/>
<input type="checkbox"/> 5. Membrane	___/___/___	_____	_____	<input type="checkbox"/>
<input checked="" type="checkbox"/> 6. Other Concrete/TPO	5/3/2010	_____	_____	<input type="checkbox"/>

ROOF - CONCRETE WITH TPO COVERING

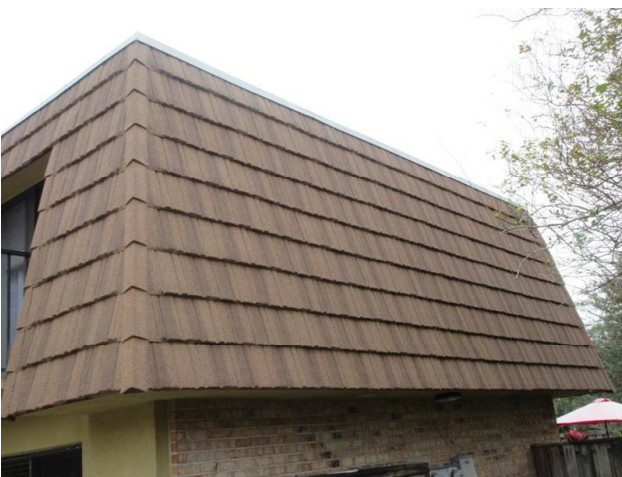
MANSARD WALLS REPLACED 2018
