Uniform Mitigation Verification Inspection Form

Inspection Date: JANUARY 30, 2020		
Owner Information		
Owner Name: MIDDLEBROOK PINES CONDOS CASE#: 20200130-WMIR-40		Contact Person: KEITH KIEBZAK
Address: 5371, 5373, 5375, 5377 BAMBOO CT - BLDG 40		Home Phone:
City: ORLANDO	Zip: 32811	Work Phone: 407-482-2622
County: ORANGE	FL	Cell Phone:
Insurance Company:		Policy #:
Year of Home: 1986	# of Stories: 2	Email: KLMGMTGROUP@AOL.COM

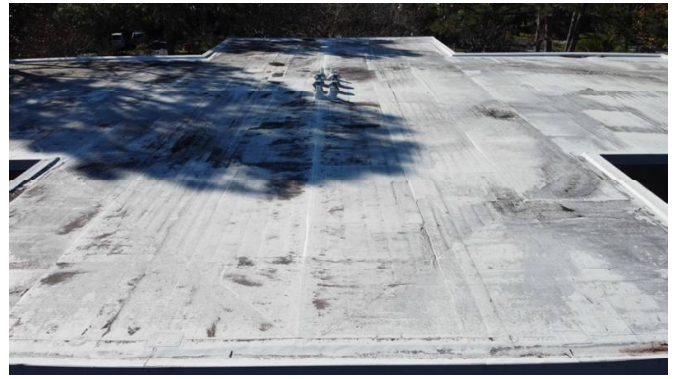
2.1 Roof Covering Type:	Permit Application Date	FBC or MDC Product Approval #	Year of Original Installation or Replacement	No Information Provided for Compliance
<input type="checkbox"/> 1. Asphalt/Fiberglass Shingle	___/___/___	_____	_____	<input type="checkbox"/>
<input type="checkbox"/> 2. Concrete/Clay Tile	___/___/___	_____	_____	<input type="checkbox"/>
<input type="checkbox"/> 3. Metal	___/___/___	_____	_____	<input type="checkbox"/>
<input type="checkbox"/> 4. Built Up	___/___/___	_____	_____	<input type="checkbox"/>
<input type="checkbox"/> 5. Membrane	___/___/___	_____	_____	<input type="checkbox"/>
<input checked="" type="checkbox"/> 6. Other Concrete/TPO	4/22/2011	_____	_____	<input type="checkbox"/>

ROOF - CONCRETE WITH TPO COVERING

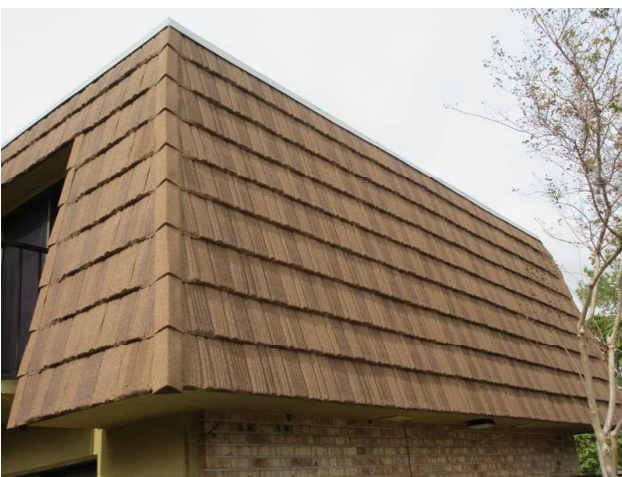
MANSARD WALLS REPLACED 2018
