Uniform Mitigation Verification Inspection Form

Inspection Date: JANUARY 30, 2020		
Owner Information		
Owner Name: MIDDLEBROOK PINES CONDOS CASE#: 20200130-WMIR-42		Contact Person: KEITH KIEBZAK
Address: 5347, 5349, 5351, 5353 BAMBOO CT - BLDG 42		Home Phone:
City: ORLANDO	Zip: 32811	Work Phone: 407-482-2622
County: ORANGE	FL	Cell Phone:
Insurance Company:		Policy #:
Year of Home: 1986	# of Stories: 2	Email: KLMGMTGROUP@AOL.COM

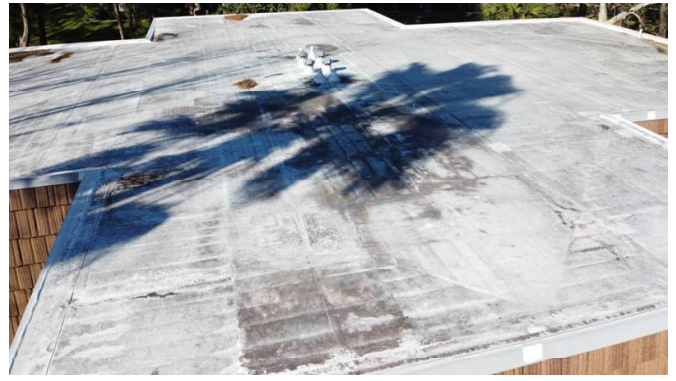
2.1 Roof Covering Type:	Permit Application Date	FBC or MDC Product Approval #	Year of Original Installation or Replacement	No Information Provided for Compliance
<input type="checkbox"/> 1. Asphalt/Fiberglass Shingle	___/___/___	_____	_____	<input type="checkbox"/>
<input type="checkbox"/> 2. Concrete/Clay Tile	___/___/___	_____	_____	<input type="checkbox"/>
<input type="checkbox"/> 3. Metal	___/___/___	_____	_____	<input type="checkbox"/>
<input type="checkbox"/> 4. Built Up	___/___/___	_____	_____	<input type="checkbox"/>
<input type="checkbox"/> 5. Membrane	___/___/___	_____	_____	<input type="checkbox"/>
<input checked="" type="checkbox"/> 6. Other Concrete/TPO	10/20/09	_____	_____	<input type="checkbox"/>

ROOF - CONCRETE WITH TPO COVERING

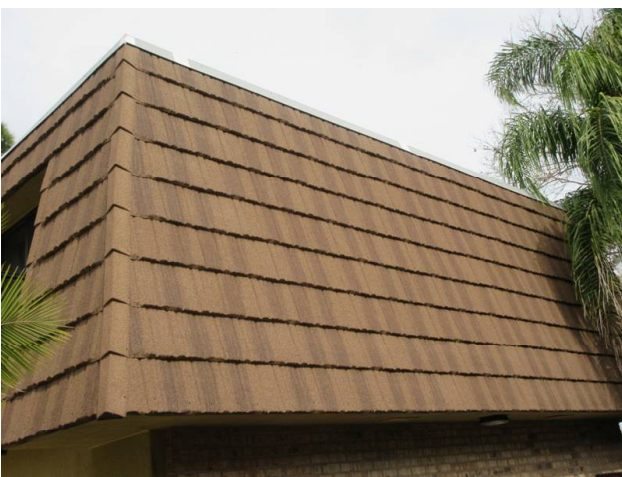
MANSARD WALLS REPLACED 2018
