# Uniform Mitigation Verification Inspection Form

| Owner Name: MIDDLEBROOK PINES CONDOS CASE#: 20200130-WMIR-43 | | Contact Person: KEITH KIEBZAK |
| Address: 5339, 5341, 5343, 5345 BAMBOO CT - BLDG 43 | | Home Phone: |

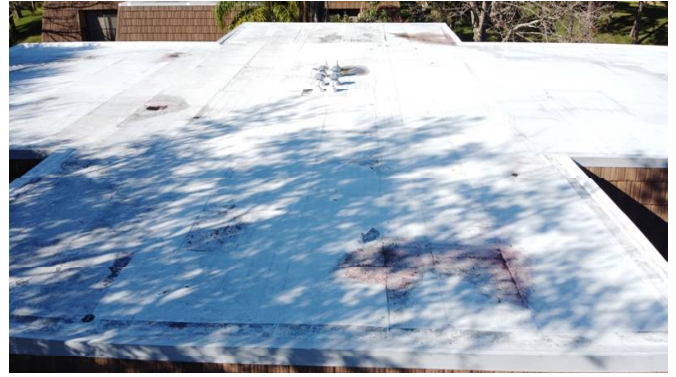
| 2.1 Roof Covering Type: | Permit Application Date | FBC or MDC Product Approval # | Year of Original Installation or Replacement | No Information Provided for Compliance |
|---|---|---|--|--|
| <input checked="" type="checkbox"/> 6. Other Concrete/TPO | 4/9/2010 | _____ | _____ | <input type="checkbox"/> |

ROOF - CONCRETE WITH TPO COVERING

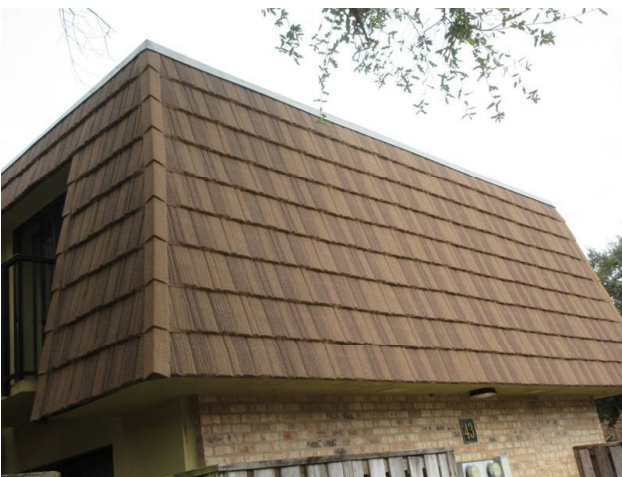
MANSARD WALLS REPLACED 2018
