Uniform Mitigation Verification Inspection Form

Inspection Date: JANUARY 30, 2020		
Owner Information		
Owner Name: MIDDLEBROOK PINES CONDOS CASE#: 20200130-WMIR-45		Contact Person: KEITH KIEBZAK
Address: 5323, 5325, 5327, 5329 BAMBOO CT - BLDG 45		Home Phone:
City: ORLANDO	Zip: 32811	Work Phone: 407-482-2622
County: ORANGE	FL	Cell Phone:
Insurance Company:		Policy #:
Year of Home: 1986	# of Stories: 2	Email: KLMGMTGROUP@AOL.COM

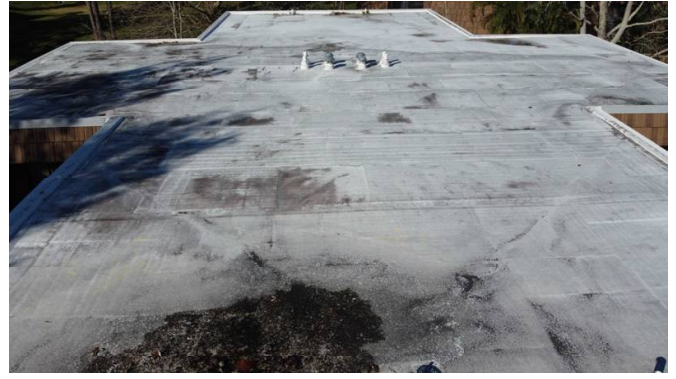
2.1 Roof Covering Type:	Permit Application Date	FBC or MDC Product Approval #	Year of Original Installation or Replacement	No Information Provided for Compliance
<input type="checkbox"/> 1. Asphalt/Fiberglass Shingle	____/____/____	_____	_____	<input type="checkbox"/>
<input type="checkbox"/> 2. Concrete/Clay Tile	____/____/____	_____	_____	<input type="checkbox"/>
<input type="checkbox"/> 3. Metal	____/____/____	_____	_____	<input type="checkbox"/>
<input type="checkbox"/> 4. Built Up	____/____/____	_____	_____	<input type="checkbox"/>
<input type="checkbox"/> 5. Membrane	____/____/____	_____	_____	<input type="checkbox"/>
<input checked="" type="checkbox"/> 6. Other <u>Concrete/TPO</u>	10/20/09	_____	_____	<input type="checkbox"/>

ROOF - CONCRETE WITH TPO COVERING

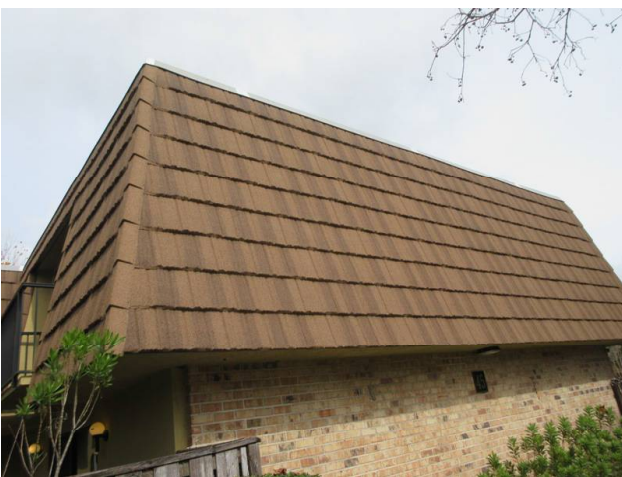
MANSARD WALLS REPLACED 2018
