Uniform Mitigation Verification Inspection Form

Inspection Date: JANUARY 30, 2020		
Owner Information		
Owner Name: MIDDLEBROOK PINES CONDOS CASE#: 20200130-WMIR-85		Contact Person: KEITH KIEBZAK
Address: 5265, 5267, 5269, 5271 CYPRESS CT - BLDG 85		Home Phone:
City: ORLANDO	Zip: 32811	Work Phone: 407-482-2622
County: ORANGE	FL	Cell Phone:
Insurance Company:		Policy #:
Year of Home: 1985	# of Stories: 2	Email: KLMGMTGROUP@AOL.COM

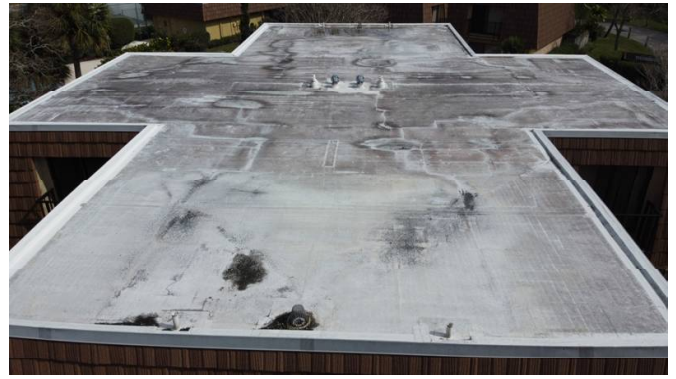
ROOF - CONCRETE WITH TPO COVERING

2.1 Roof Covering Type:	Permit Application Date	FBC or MDC Product Approval #	Year of Original Installation or Replacement	No Information Provided for Compliance
<input type="checkbox"/> 1. Asphalt/Fiberglass Shingle	___/___/___	_____	_____	<input type="checkbox"/>
<input type="checkbox"/> 2. Concrete/Clay Tile	___/___/___	_____	_____	<input type="checkbox"/>
<input type="checkbox"/> 3. Metal	___/___/___	_____	_____	<input type="checkbox"/>
<input type="checkbox"/> 4. Built Up	___/___/___	_____	_____	<input type="checkbox"/>
<input type="checkbox"/> 5. Membrane	___/___/___	_____	_____	<input type="checkbox"/>
<input checked="" type="checkbox"/> 6. Other Concrete/TPO	6/27/2011	_____	_____	<input type="checkbox"/>

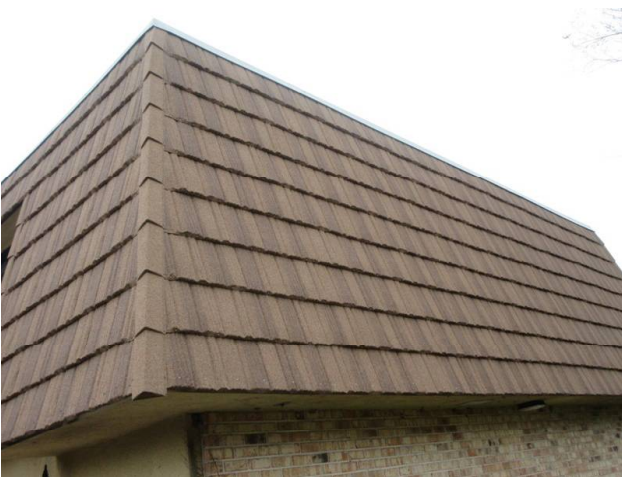
MANSARD WALLS REPLACED 2018
